The Church of St Mary
Thornthwaite cum Braithwaite, Cumbria, CA12 4QD.
Diocese of Carlisle

CONDITION SURVEY 2016

Prepared on behalf of the Parochial Church Council
by
Peter Kempsey Dip Arch AABC and Ian Wells B Arch RIBA
Countryside Consultants, Townhead, Alston, Cumbria CA9 3SL
Tel: 01434 381906 E mail: info@countryside-consultants.co.uk

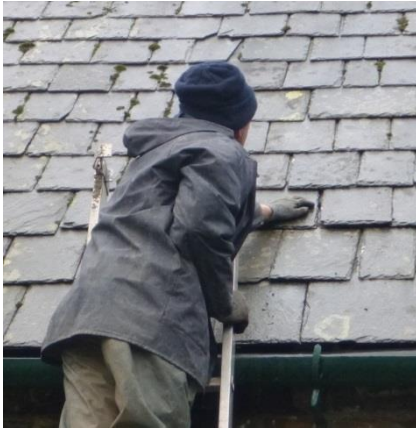
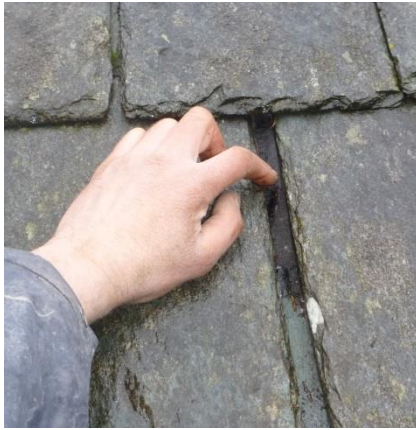
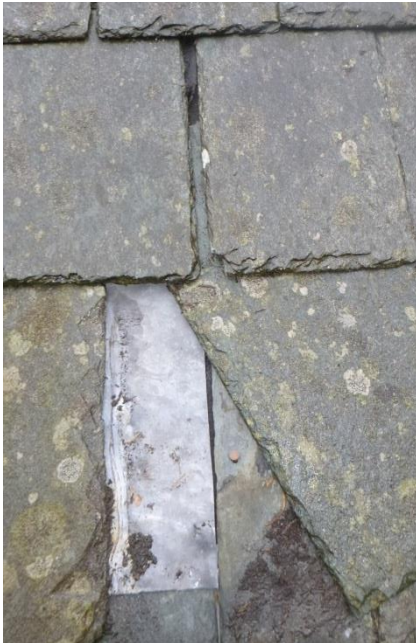
EXISTING SLATE WEATHERING

This is in poor condition. It seems to have been patched many times.

The photo to the left shows a leadwork patch.

The building contract documents for the work of 1993 asked for major patching of this pitch.

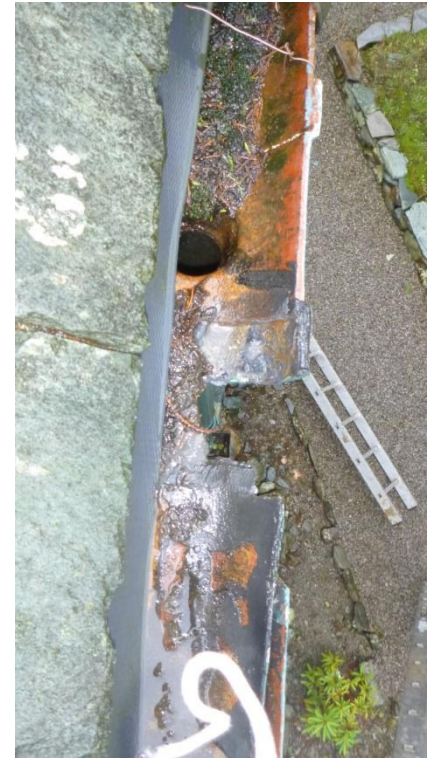
EXISTING CAST IRON GUTTERING

The gutter is blocked by a recently inserted drip flashing which has slipped into the gutter. A cracked section of gutter prevents water getting to the down pipe. Currently water is running from the gutter down the face of the wall.

2.01 Initial repairs required this spring

2.02 longer term re roofing

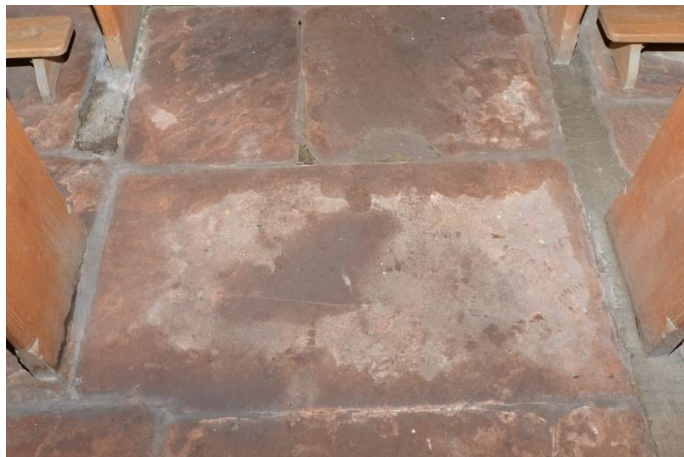
SANDSTONE FLAGS IN THE CENTRAL AISLE

The dark areas are damp. This could be rising damp and also condensation. The feet of the pews are fixed to the floor with mirror plates and woodscrews into plugs.

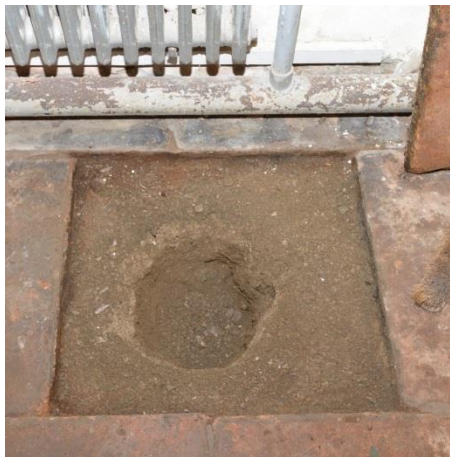
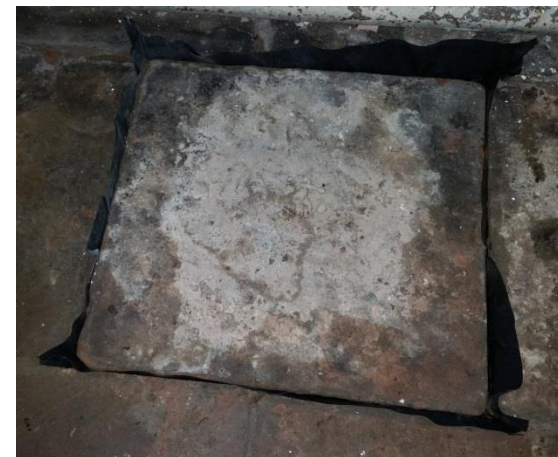
OPENING UP THE FLOOR AND INSTALLING A TEMPORARY DPM

The flags are laid directly onto gravelly earth. The base of the 350mm deep pit was left open for about 2 hours. During that time the base did not get any wetter. The underside of the lifted flag was damp. There is no evidence of any type of damp proof membrane ever being installed. This must be the main source of humidity in the church. We have installed a temporary DPM below the flag that was lifted. This experiment should help establish whether the issue is 'rising damp' or condensation.

2.03 Floor works

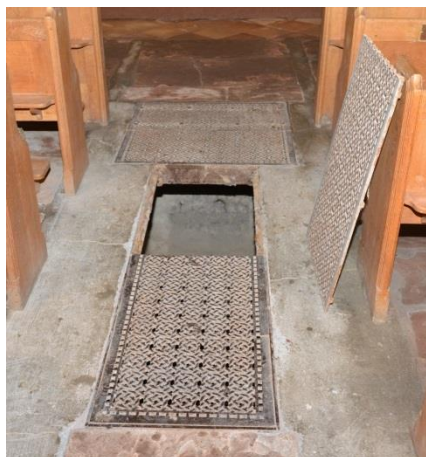
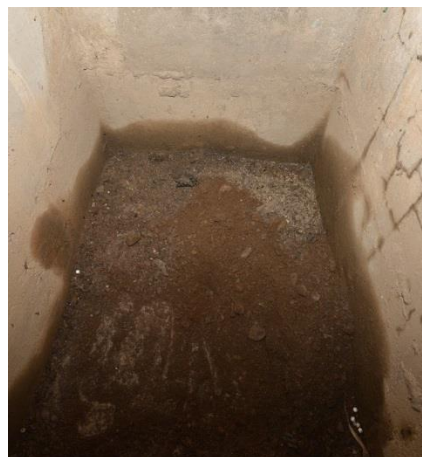
OLD HEATING CHAMBER

The iron grille in the aisle of the nave covers a chamber about 1500mm deep. This would have been part of a ducted air heating system. If the floor was to be re-laid the void would be infilled.

2.04 Heating system

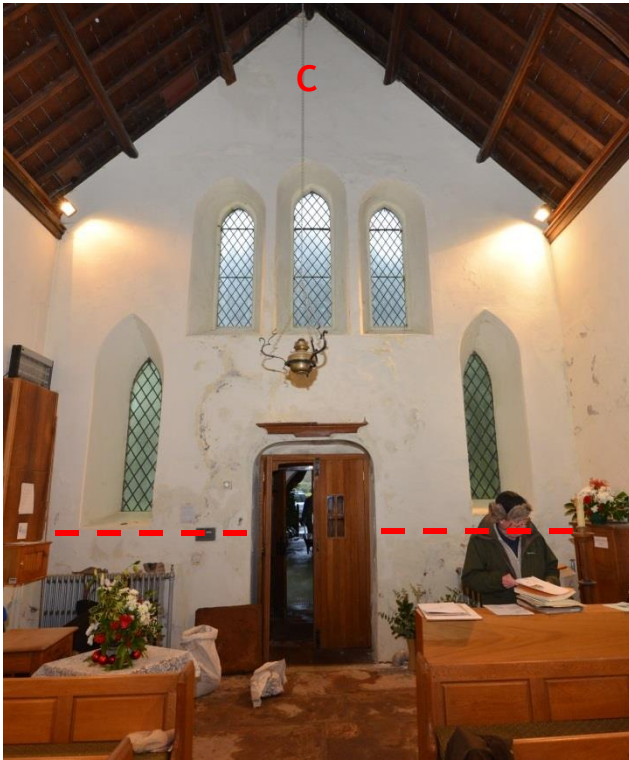
EXISTING LOW LEVEL PLASTERWORK

In reasonable condition. It could well be original lime plaster.

CC Note: Bellcote does not seem to be leaking.

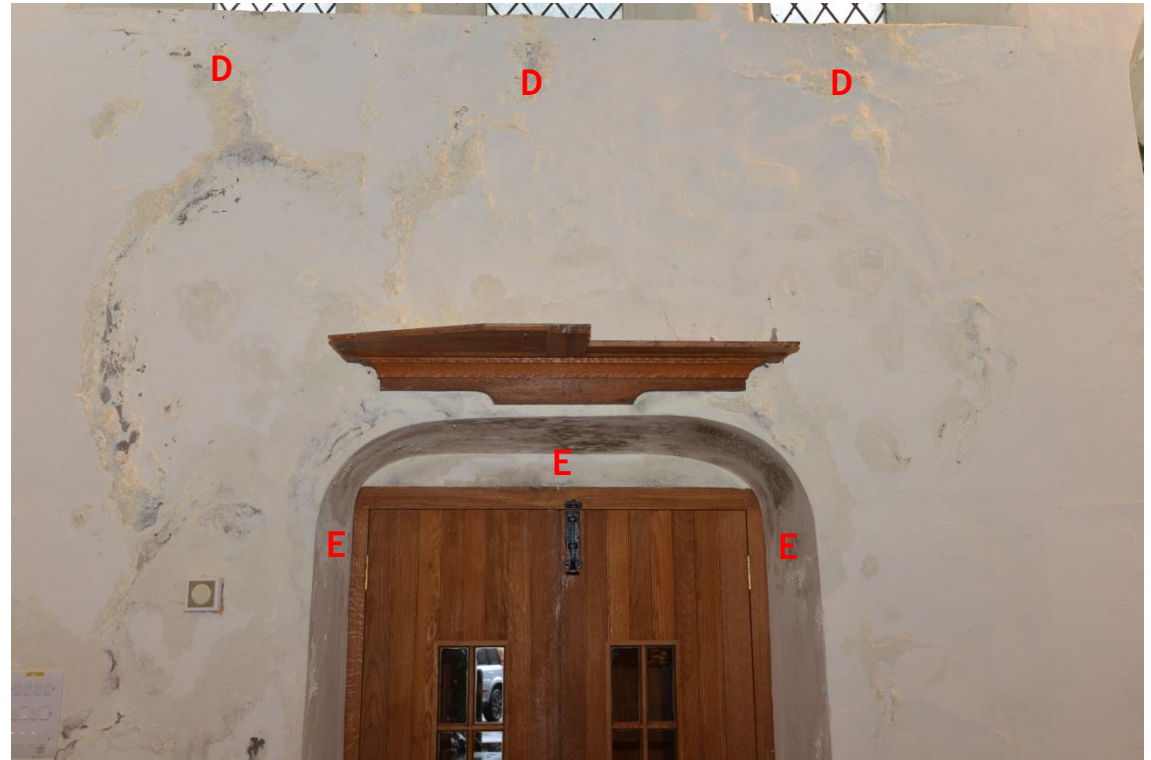
AREA D PLASTERWORK

Being damaged by water currently running down the wall from the leaking high level windows.

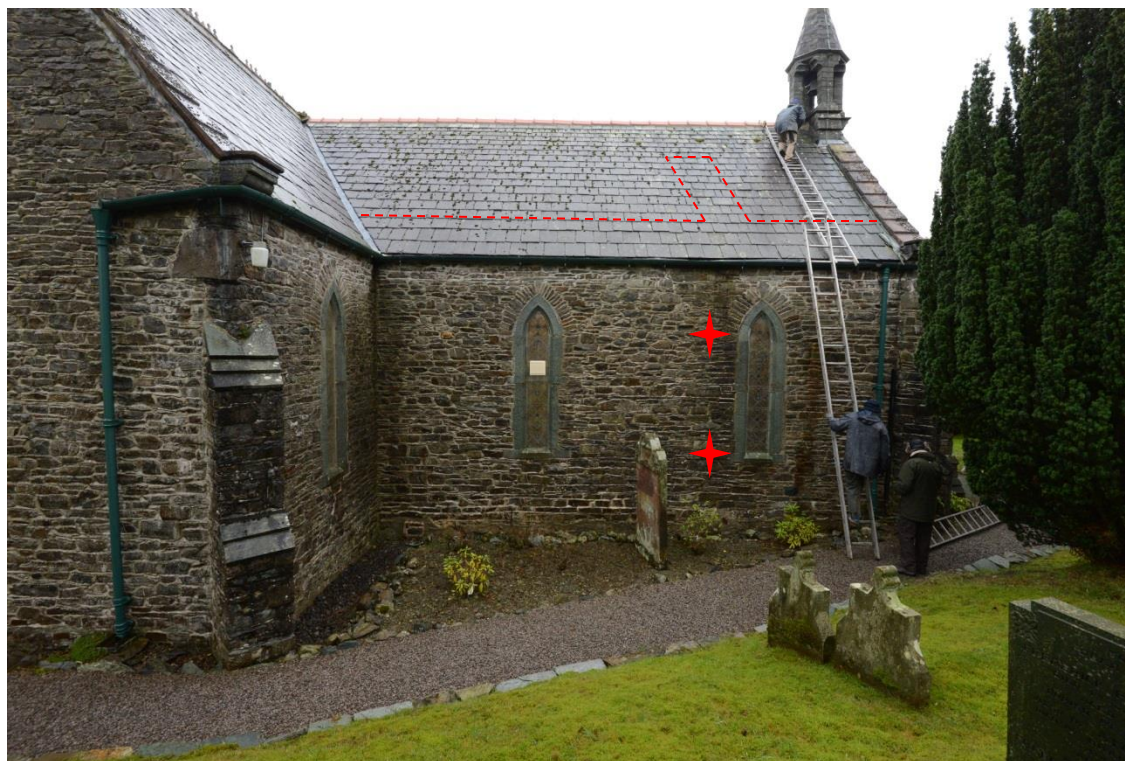
BASE OF THE EXTERNAL WALL The voids in the wall bases have been filled with grout to approximately 250mm above floor level.

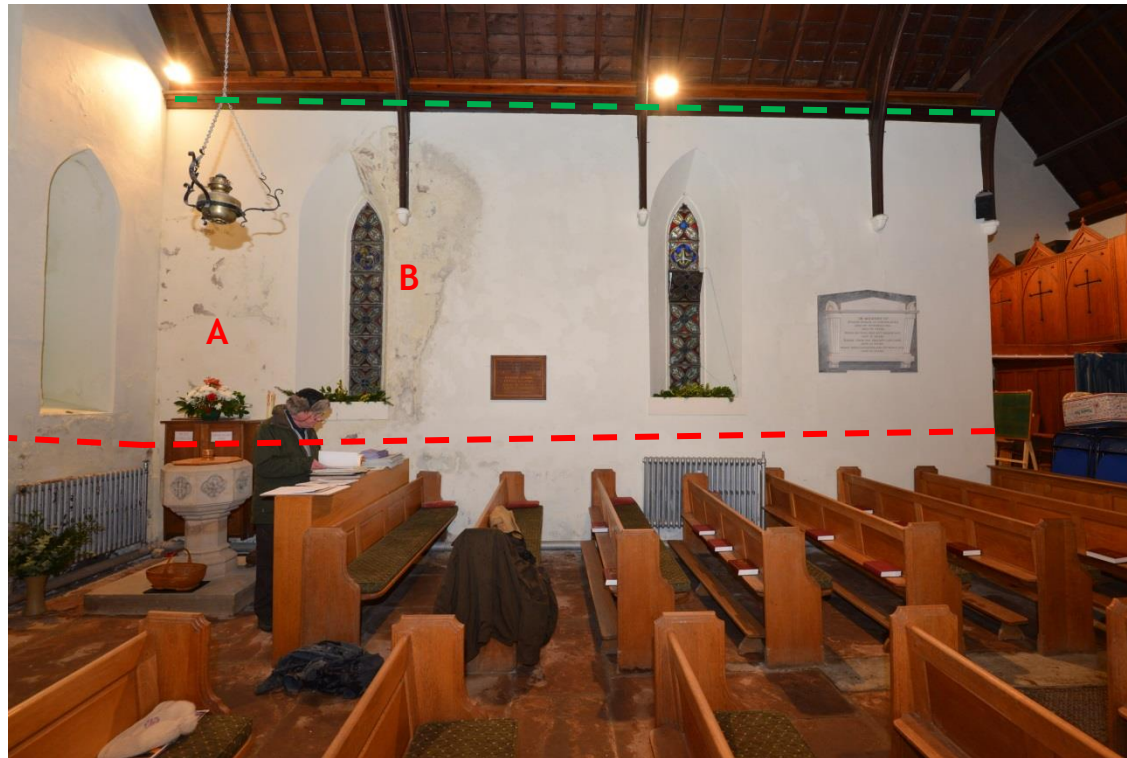
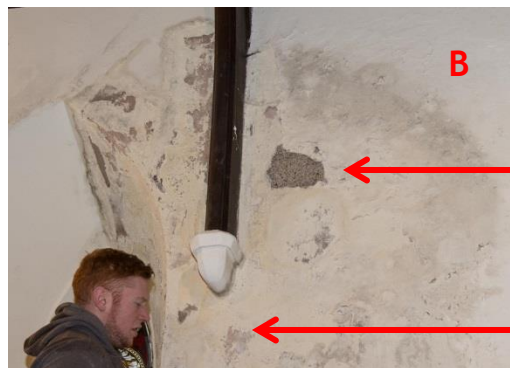
Basecoat lime plaster possibly original

Topcoat recent pink gypsum finishing skim

2.08 Internal wall face works

2.09 Internal paint finishes

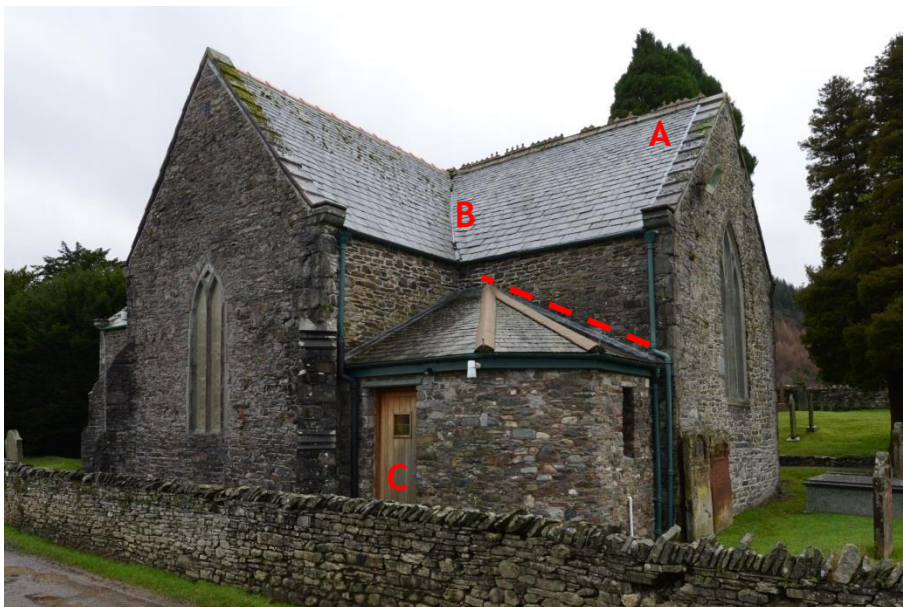
EXISTING FLASHING OVER DISABLED WC

The dampness in the WC could be entering from the core of the original wall above.

Access roof void over WC to see if there are any clues as to where the moisture is coming from. If there is condensation occurring consider improving the ventilation of the roof void. If the dampness is coming in from the church wall install a cavity tray into the masonry wall over the lead flashings of the extension.

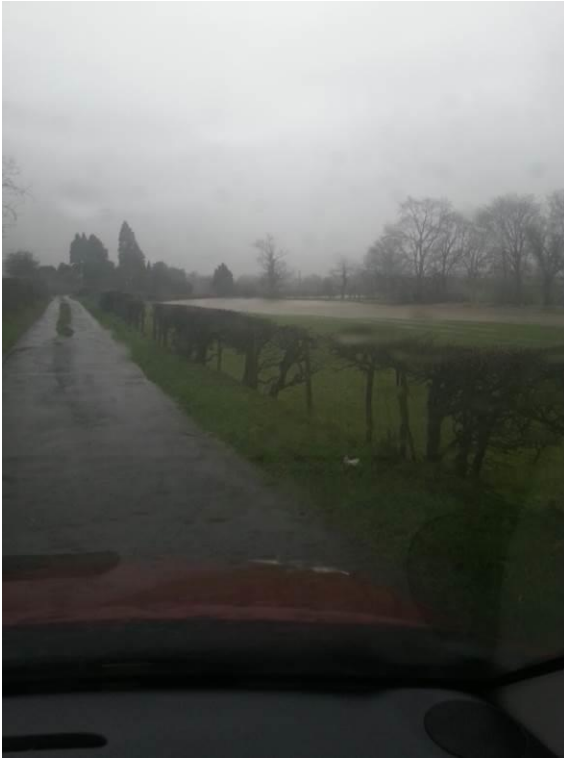
Photo 1: Taken from approximately 50 metres from the church on the access road from the west. The Church Beck water course has flooded into the field to the south west of the church.

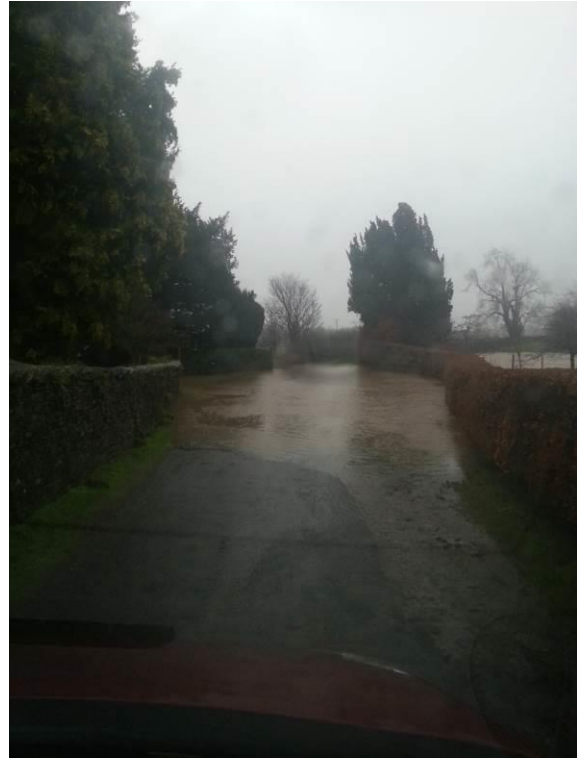
Photo 2: Taken from the access road looking at the car parking area. Church yard boundary wall on the left. The car parking area and the field south west are flooded.

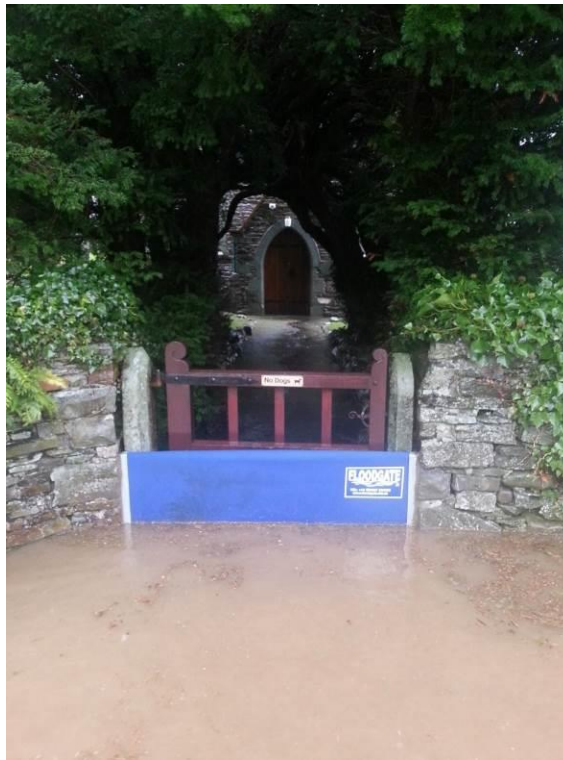
Photo 6: Car park area looking north east towards the church. Flood gate 'A' and church wall are holding the water back well. Later the water rose to approximately 50mm above the top of the flood gate. The water level when the photo was taken is estimated as 80.60 metres which is approximately 800mm above the floor level of the church. At the maximum level the water would have been nearly 1000mm above the floor level of the church.

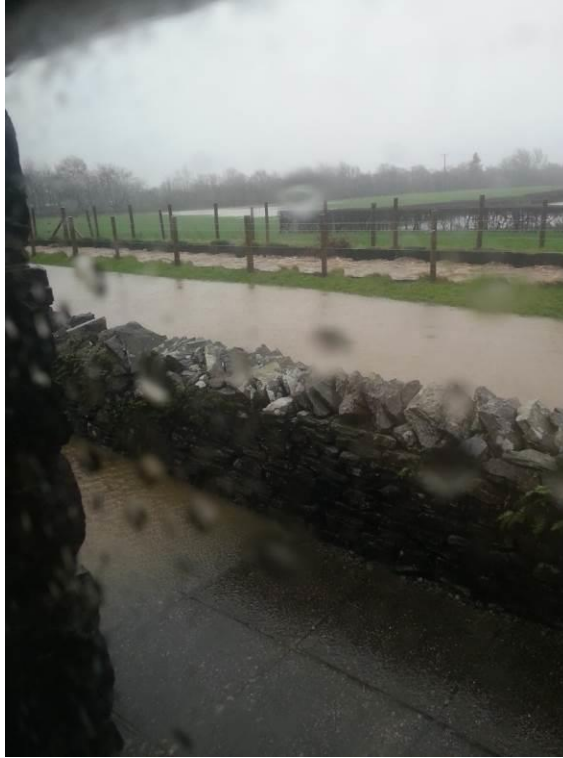
Photo 7: Taken from the doorway of the kitchen extension looking west. The Church Beck (between the two wire fences) is running at an approximate level of 79.70 metres. This is roughly 70mm below the floor level of the church. The water over the farm track is at about the same level as is the water in the church yard. This can be seen in the photo running across the paving flags of the access path. These flags are set at the same level as the church floor to enable disabled access.

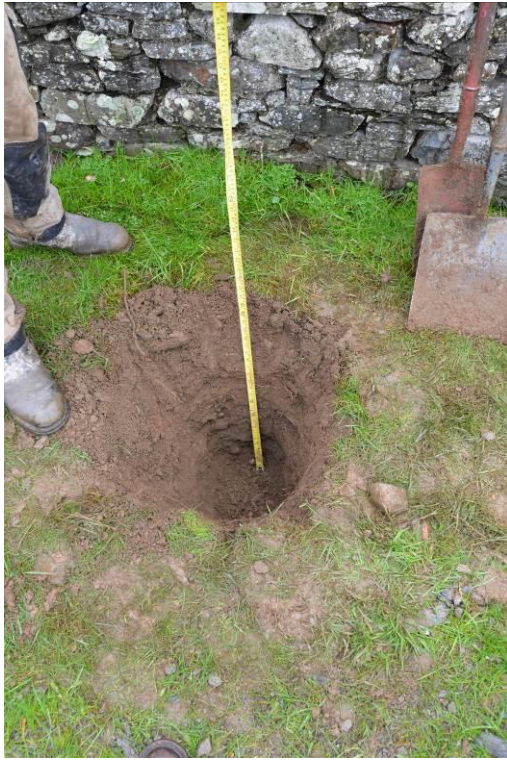
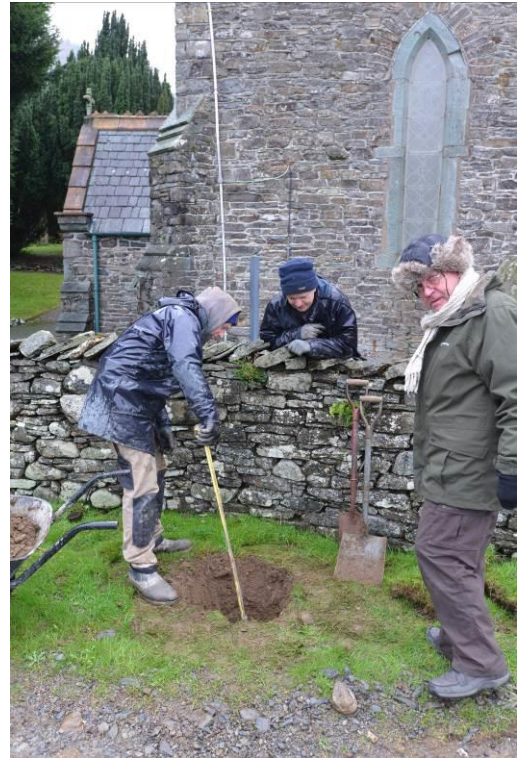
Photo 10A

The trial pit was dug on the 12 January 2016 in the verge of the farm track. The location is indicated on drawing S1. The level of the base of the pit was 78.99. This was just below the water level of 79.06 in the Church Beck water course.
